CH-47 ACCIDENT SUMMARY

1 July 1966 through 30 June 1967

by
P. R. Thompson

Education and Literature Division

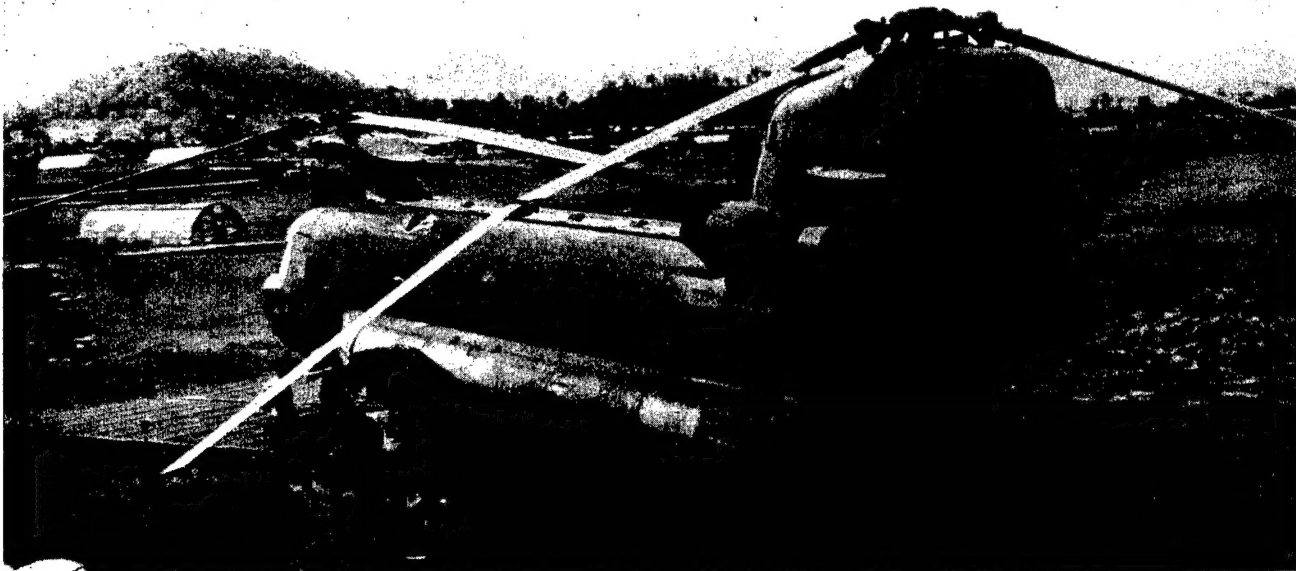
011506—Aircraft disintegrated in air. Six crew-

members and three passengers killed. Caused by fatigue failure of spar of one aft rotor blade at station 200.5.

011506-Fatigue failure of aft rotor blade spar caused aircraft to disintegrate during flight.
